AMERICAN EMERGENCY VEHICLES

TECHNICAL BULLETIN

Subject: Chevrolet/GMC G3500 chassis electrical junction

GM3500 Cargo and Cutaway Alternator Terminal Block Hookup

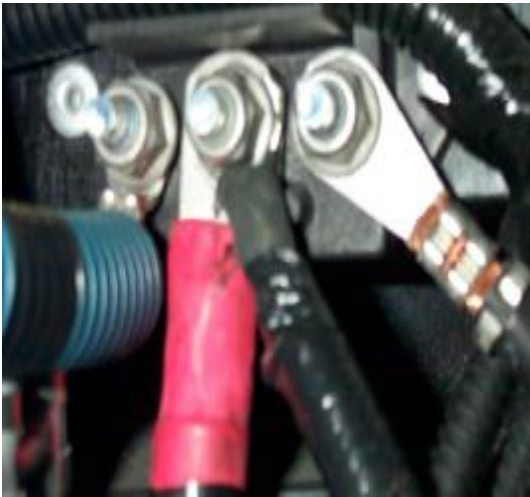
Correct Hookup
Four cables connected

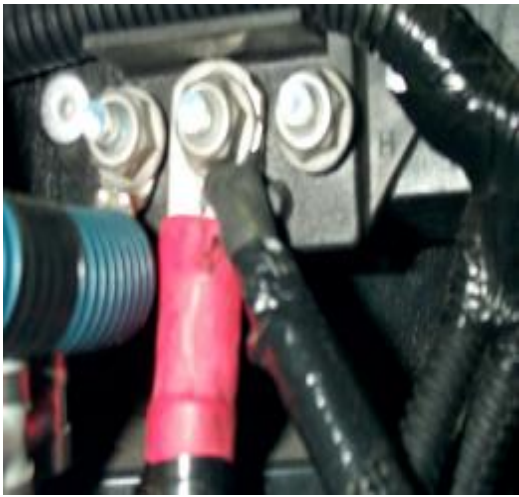
In some cases, the GM factory failed to attach the output cable originating from the lower alternator to the designated electrical junction post located in the engine compartment near the passenger side headlight. The alternator cable has a lug on the distal end, and the loose end may be found unattached in various locations in the engine compartment on chassis that are improperly built.

We are not aware of any operational breakdowns caused by GM's failure to connect the second alternator. However, it should be noted that the loose cable would likely be hot while the vehicle is under operation, and there may be risk of shock or fire.

Incorrect Hookup
Only 3 cables, can be on any of three lugs
